**United States Air Force
611th Civil Engineer Squadron**

Final

**Remedial Investigation Report
Galena Airport and Campion Air Station**

March 1996

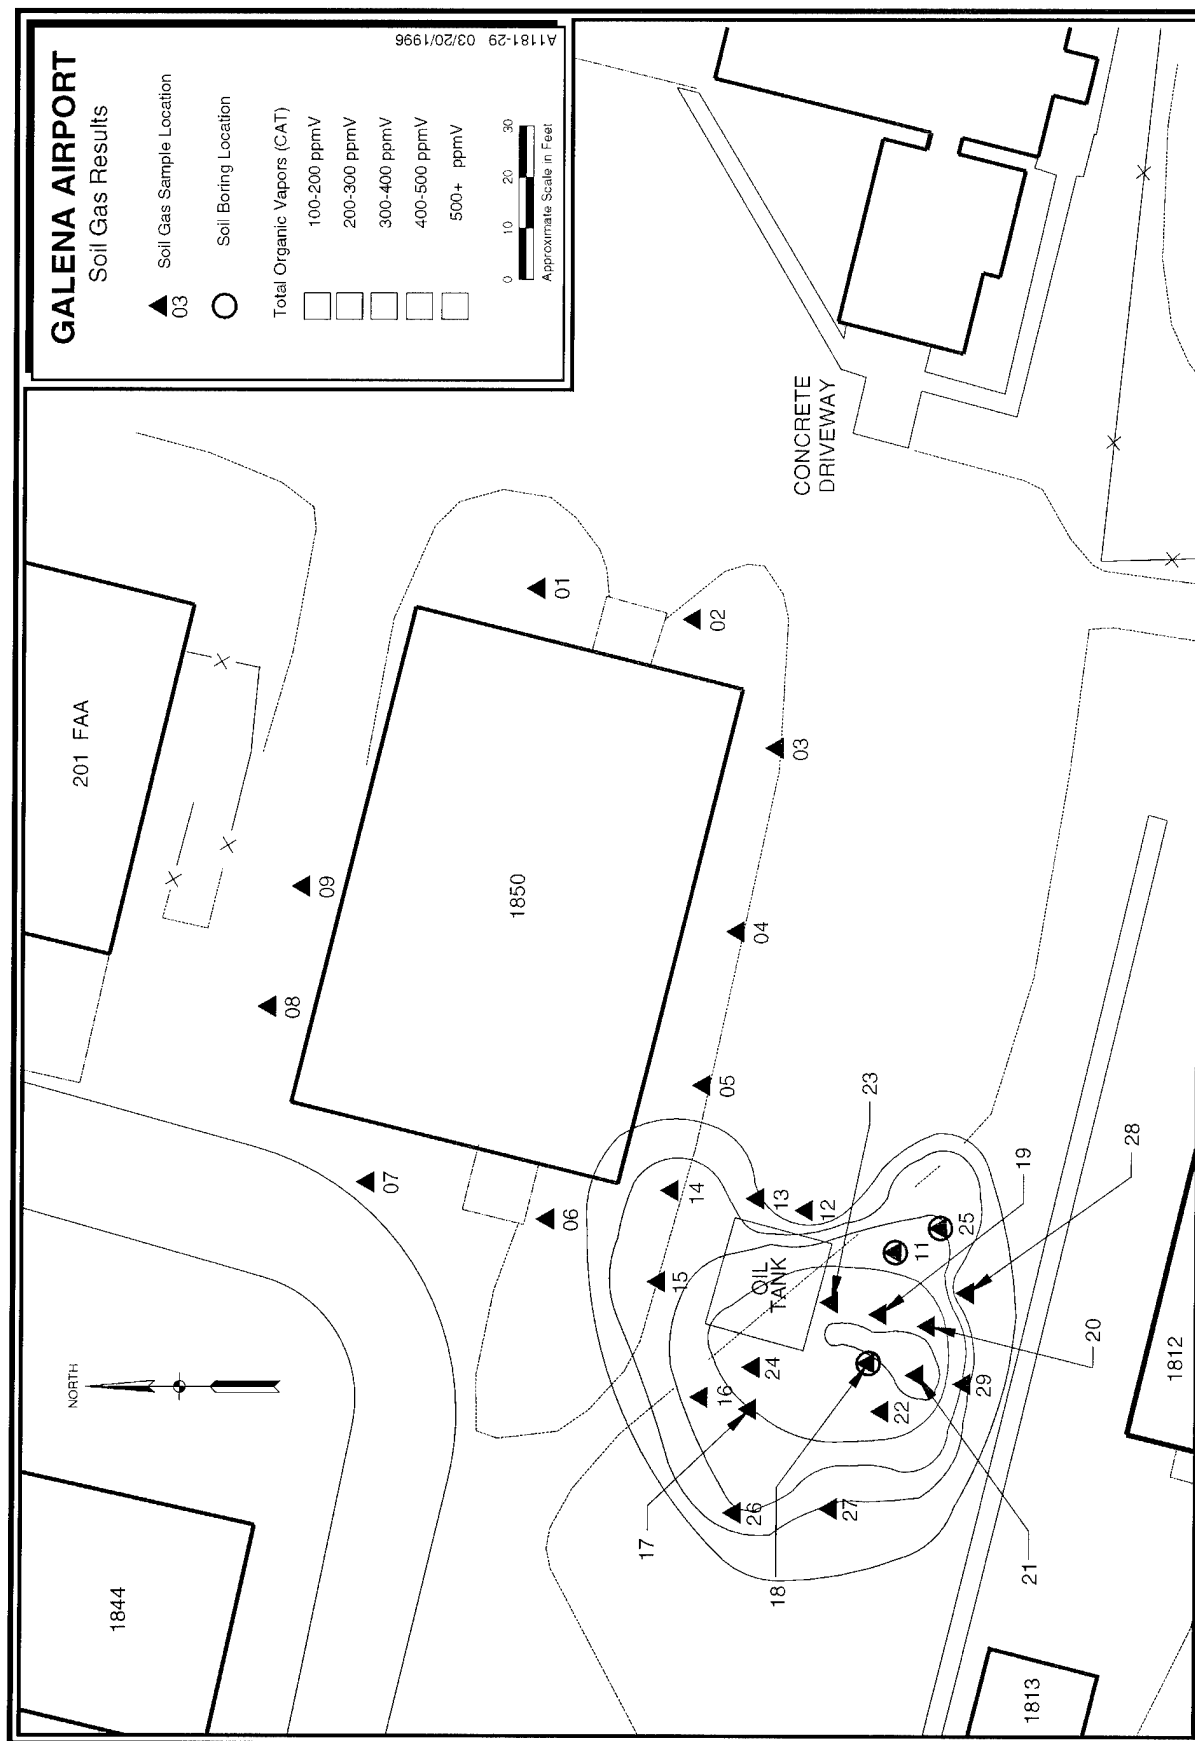
Figure 3.4-9. Soil Gas Survey Results for the Building 1850 Source Area

Sampling Location	Field IR Analysis (mg/kg)	
	AH	TPH
11	36	1182
12	2	56
13	ND	6
16	2	3
17	2	211
18	10	210
19	3.2	149
20	1	11
23	7	67
24	30	273
25	47	792
